# Investigation of the Breakdown Voltage Degradation under Hot-Carrier Injection in STI-based PchLDMOS Transistors

Hiroataka Kasai, Daisuke Shinohara, Mariko Shimizu, Yoshiaki Ishii, Kanako Komatsu, Toshihiro Sakamoto, Koji Yonemura and Fumitomo Matsuoka

Toshiba Electronic Devices & Storage Corporation  
 580-1, Horikawa-Cho, Saiwai-Ku, Kawasaki, Kanagawa 212-8520, Japan,  
 E-mail: hiroataka1.kasai@toshiba.co.jp

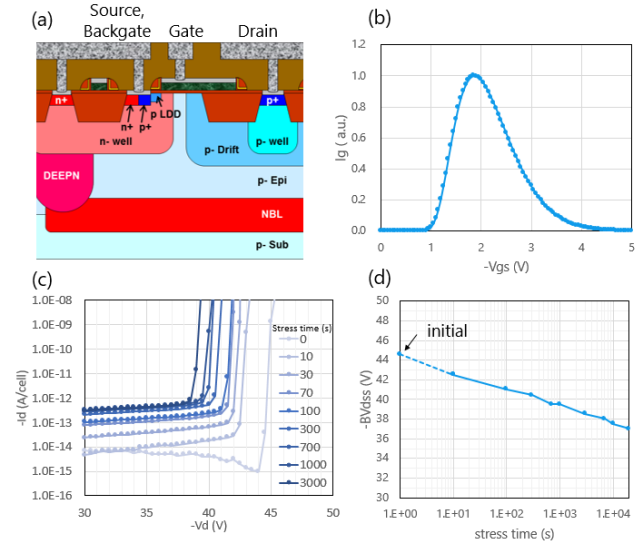
Cross sectional view of the DRIFT PchLDMOS with 0.13  $\mu\text{m}$  CMOS-DMOS technology is shown in Fig. 1(a). In order to determine the DAHC stress condition,  $I_g$  -  $V_{gs}$  curve was measured (Fig. 1(b)). The  $V_{gs}$  at the  $I_{g\_max}$  is used as the condition of DAHC stress which the impact-ionization occurs

the most. Fig. 1(c) shows the breakdown characteristics of a 40V DRIFT PchLDMOS under the DAHC stress, and it is shown that the BV<sub>dss</sub> decreases immediately after the test started and decreases continuously during the test (Fig. 1(d)).

**Fig. 1:** (a) Cross-sectional view of the DRIFT PchLDMOS structure, (b) Measured  $I_g$ - $V_{gs}$  curve of the PchLDMOS ( $V_d = -40\text{V}$ ,  $-40^\circ\text{C}$ ), (c) Measured breakdown characteristics of the PchLDMOS under DAHC stress (stress condition:  $V_d = -40\text{V}$ ,  $V_{gs} = -1.85\text{V}$ ,  $-40^\circ\text{C}$ ) and (d) Dependence of BV<sub>dss</sub> ( $I_d = -0.01 \mu\text{A/cell}$ ) on DAHC stress time (stress condition:  $V_d = -40\text{V}$ ,  $V_{gs} = -1.85\text{V}$ ,  $-40^\circ\text{C}$ ).

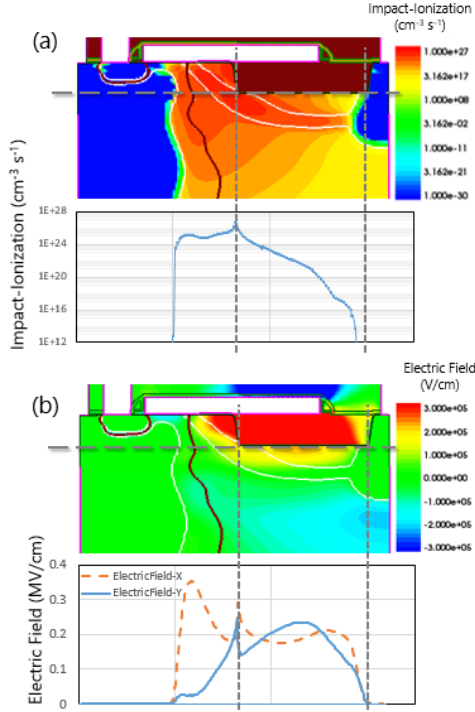
Fig. 2 shows the TCAD (Synopsys Sentaurus) simulated results of the PchLDMOS under the DAHC stress. A peak of impact-ionization exists at the STI corner (Fig. 2(a)). However, it is noted that the strong vertical electron attractive electric field ( $ElectricField-Y$ ) exists at the bottom of STI (Fig. 2(b)). The amount of  $ElectricField-Y$  has two peaks both at the STI corner and STI bottom. In the case of the STI corner, the horizontal electron attractive electric field ( $ElectricField-X$ ) is larger than the  $ElectricField-Y$ , and it results in hot-electron flowing to the source direction without being injected into the STI corner. On the contrary, the  $ElectricField-Y$  at the STI bottom is larger and dominates the hot-electron flow, which results in injection into STI bottom region. Therefore, it is considered that the hot-electron is injected and trapped at the STI bottom region rather

**Fig. 2:** 2D TCAD simulation results and 1D horizontal profiles under the STI bottom region: (a) Impact-ionization and (b) Electric field distribution during DAHC stress ( $V_d = -40\text{V}$ ,  $V_g = -2.0\text{V}$ ,  $27^\circ\text{C}$ ).

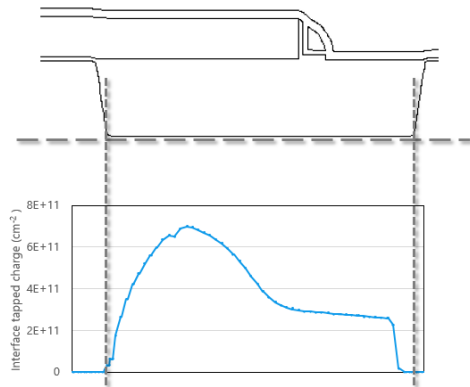
than STI corner. Fig. 3 is the distribution of trapped negative charge after  $1 \times 10^5$  s of DAHC stress calculated by TCAD simulation. It is shown that the trapped negative charge distributed along STI/Si interface, and has a peak at the STI bottom some distance away from the STI corner. To estimate the influence of trapped negative charge on BVdss, BVdss of the PchLDMOS with fixed negative charge at the bottom of the STI is simulated (Fig. 4). It is verified that the BVdss decreases due to the fixed negative charge at the STI bottom, even though no fixed negative charge is added at the corner of STI.

**Fig. 3:** 1D horizontal profile of trapped negative charge at the interface between STI bottom and Si after  $1 \times 10^5$  s of DAHC stress ( $V_d = -40\text{V}$ ,  $V_g = -2.0\text{V}$ ,  $27^\circ\text{C}$ ).

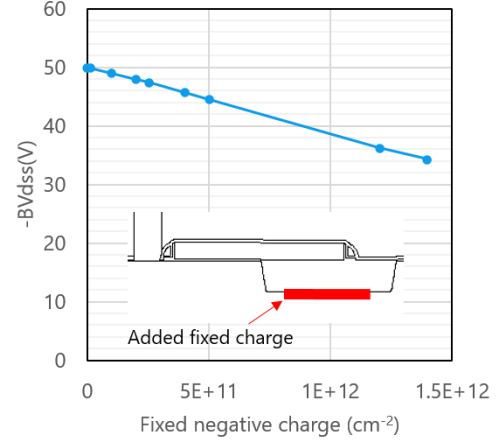
**Fig. 4:** Simulated BVdss dependence of the DRIFT structure on fixed negative charge at the STI bottom.

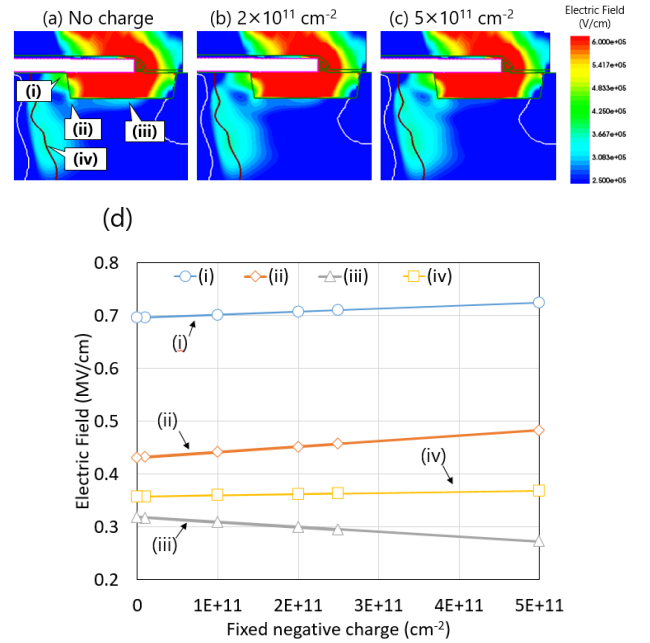
To understand this phenomenon further, electric field distribution at BVdss measurement condition ( $V_d = -40\text{V}$ ,  $V_g = 0\text{V}$ ) with fixed negative charge along the STI bottom is simulated (Fig. 5). As the amount of fixed negative charge increases, electric field of the STI bottom (point (iii)) decreases, while the other points (i), (ii) and (iv) increase. Therefore, the breakdown voltage is degraded because of the collapse in the balance of the electric field distribution in the drift region. This electric field change can be explained as follows. The trapped electron at the STI/Si interface attracts hole, which lowers the resistance beneath the STI bottom. As a result, electric field at the bottom of the STI decreases (Fig. 5(d) and Fig. 6), and electric field at the STI corner is intensified instead.

**Fig. 5:** Electric field distribution of the DRIFT PchLDMOS ( $V_d = -40\text{V}$ ,  $V_g = 0\text{V}$ ,  $27^\circ\text{C}$ ) with fixed negative charge at the STI bottom: (a) No charge, (b)  $2 \times 10^{11} \text{ cm}^{-2}$ , (c)  $5 \times 10^{11} \text{ cm}^{-2}$  and (d) The maximum intensity of electric field at each region.

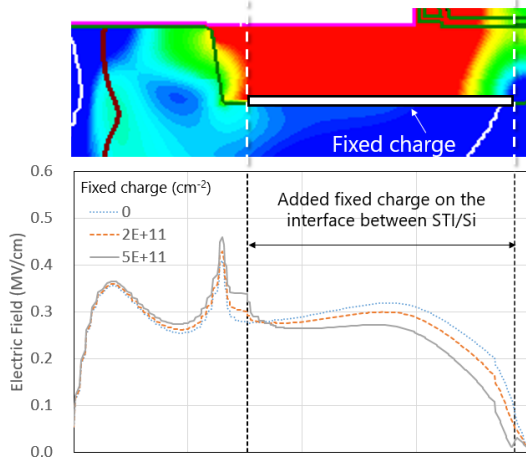
**Fig. 6:** Dependence of the electric field of the DRIFT PchLDMOS ( $V_{ds} = -40V$ ,  $V_{gs} = 0V$ ,  $27^\circ C$ ) on the fixed negative charge.

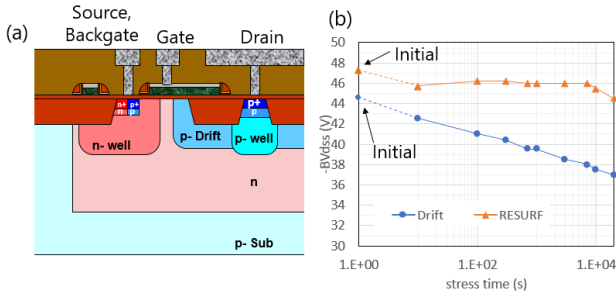
As a result of the DRIFT PchLDMOS structure, the RESURF PchLDMOS structure (Fig. 7(a)) could be a candidate which is tolerant against the  $BV_{dss}$  degradation. The existence of an additional junction underneath the drift region would be expected to share the total electric field of drift region. Fig. 7(b) shows dependence of  $BV_{dss}$  of a 40V RESURF PchLDMOS on DAHC stress time, with the result of the DRIFT structure case. As for the RESURF structure, the  $BV_{dss}$  degradation does not occur until  $1 \times 10^3$  s, and it is clearly more tolerant against  $BV_{dss}$  degradation than DRIFT structure.

**Fig. 7:** (a) Cross-sectional view of the RESURF PchLDMOS structure. (b) Measured breakdown characteristics of the RESURF PchLDMOS under DAHC stress (stress condition:  $V_{ds} = -40V$ ,  $V_{gs} = -1.90V$ ,  $-40^\circ C$ ) and the DRIFT PchLDMOS.

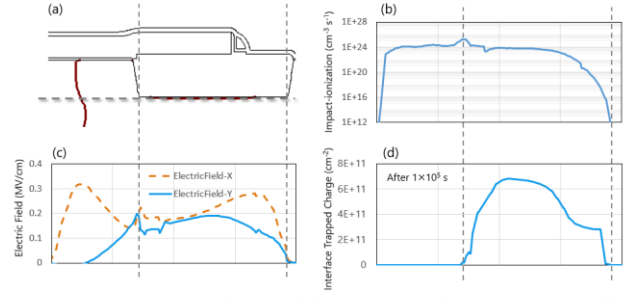
Same TCAD simulations as the DRIFT structure were carried out (Fig. 8). These results confirmed that, also in the case of the RESURF structure, the distribution of the *ElectricField-X*, *Y*, and hot-electron induced trapped negative charge position show similar tendency to DRIFT structure.  $BV_{dss}$  dependence of the RESURF structure on fixed negative charge was also simulated (Fig. 9). As already observed in the DRIFT structure, the fixed negative charge at the STI bottom decreases its  $BV_{dss}$  (Fig. 4), however, as for the RESURF structure, it is noted that the  $BV_{dss}$  improved by adding trapped negative charge up to

**Fig. 8:** (a) Cross-sectional view of the RESURF PchLDMOS. 1D profiles under the STI bottom of the PchLDMOS: (b) Impact-ionization and (c) Electric field at DAHC stress ( $V_{ds} = -40V$ ,  $V_{gs} = -2.0V$ ,  $27^\circ C$ ), and (d) Interface trapped negative charge after  $1 \times 10^5$  s of the DAHC stress.

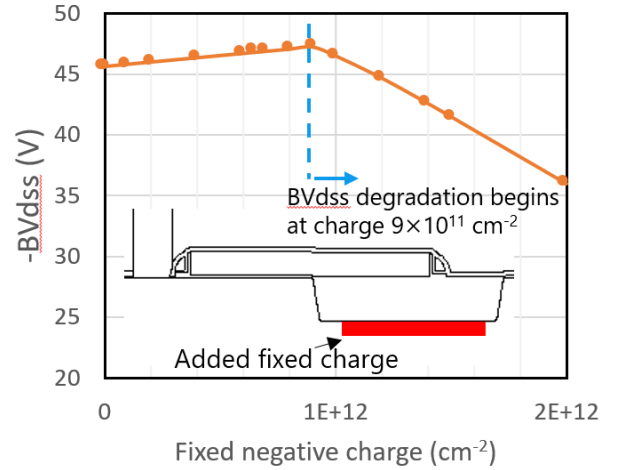
**Fig. 9:** Simulated  $BV_{dss}$  dependence of the RESURF structure on fixed negative charge at the STI bottom.

$9 \times 10^{11} \text{ cm}^{-2}$ , and after the trapped negative charge exceed a threshold amount, the  $BV_{dss}$  starts decreasing. This result has a good agreement with the measurement result (Fig. 7(b)).

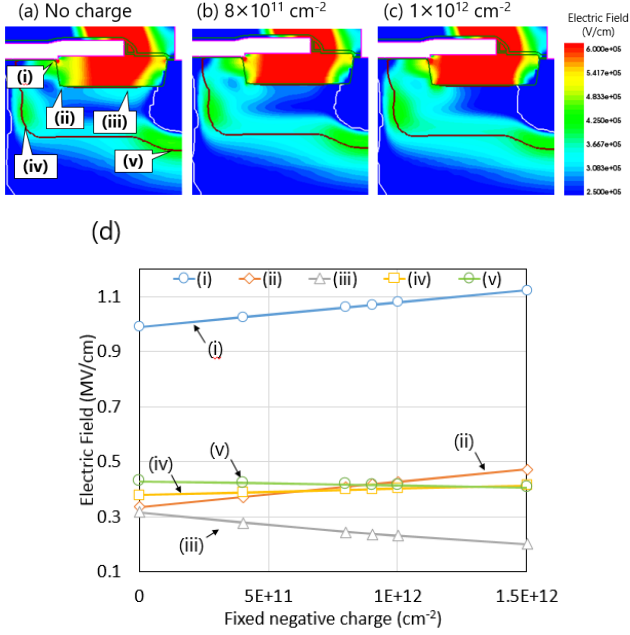
Electric field distribution of the RESURF structure under  $BV_{dss}$  condition ( $V_{ds} = -40V$ ,  $V_{gs} = 0V$ ) with fixed negative charge along STI bottom was also simulated (Fig. 10). In the case of the RESURF structure, a higher electric field at the bottom of drain (point (v)) is added compared to the DRIFT structure. As the trapped negative charge increases, the electric field intensity at point (iii) and (v) decrease, while the other points (i), (ii) and (iv) increase. When the trapped negative charge is larger than  $8 \times 10^{11} \text{ cm}^{-2}$ , the electric field intensity at point (ii) exceeds that at point (v). This result corresponds to the relation between the  $BV_{dss}$  degradation and the electric field distribution balance. In order to investigate this breakdown behavior at the conversion point, further TCAD simulation was carried out. Fig. 11 shows the electron and hole current density distributions at the fixed negative charge of  $8 \times 10^{11}$  and  $1 \times 10^{12} \text{ cm}^{-2}$ , which show the states before and after the electric field intensities at point (v) and (ii) are reversed. When the electric field of point (v) is higher than (ii), electron flows through the point (v) (Fig. 11(a)). Due to this current, potential of the n-type region under the drift region is negatively biased and a parasitic p-n-p transistor, which consists of the emitter (source), the base

**Fig. 10:** Electric field distribution of the RESURF PchLDMOS ( $V_d = -40\text{V}$ ,  $V_g = 0\text{V}$ ,  $27^\circ\text{C}$ ) with fixed negative charge at the STI bottom: (a) No charge, (b)  $8 \times 10^{11} \text{ cm}^{-2}$ , (c)  $1 \times 10^{12} \text{ cm}^{-2}$  and (d) The maximum intensity of electric field intensity at each region.

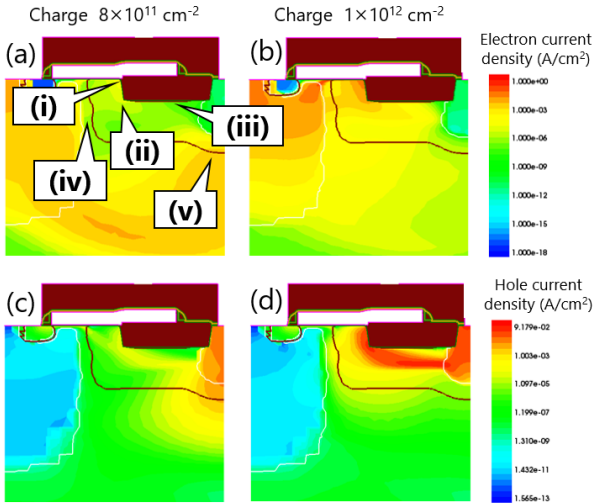
(backgate) and the collector (drain), is turned on. This parasitic p-n-p transistor current causes the drain-source breakdown. Whereas, after the electric field intensity at the point (ii) exceeds the point (v), the hole current flows from the source to drain via the STI corner (Fig. 11(d)), which suggests that the breakdown occurs at the STI corner. These results can explain the different BV<sub>dss</sub> degradation behavior of the RESURF structure from DRIFT structure. The existence of point (v), which is the region insusceptible to STI trapped negative charge, suppresses BV<sub>dss</sub>

**Fig. 11:** The distributions of electron and hole current density at the breakdown of the RESURF PchLDMOS ( $V_d = \text{BV}_{dss}$ ,  $V_g = 0\text{V}$ ,  $27^\circ\text{C}$ ) with fixed negative charge: (a) Electron current density at fixed negative charge  $8 \times 10^{11} \text{ cm}^{-2}$  and (b)  $1 \times 10^{12} \text{ cm}^{-2}$ ; (c) Hole current density at negative charge  $8 \times 10^{11} \text{ cm}^{-2}$  and (d)  $1 \times 10^{12} \text{ cm}^{-2}$ .

degradation to the extent that the electric field at point (ii) is less than that of point (v). After the electric field at point (ii) exceeds that at point (v), the BV<sub>dss</sub> degradation starts by the same mechanism as the DRIFT structure, which is caused by the collapse of electric field distribution balance in the drift region. Therefore, the RESURF structure is tolerant against the BV<sub>dss</sub> degradation.
