Important Notices

Restriction on Use of 8-bit Timers

With regard to our TLCS-900/L1 Series and TLCS-900/H1 Series of 16-bit microcontrollers, we have found that the following problem may occur when 8-bit timers are used under certain conditions.

Datasheet Modifications: PWM Cycle of 8-bit Timers

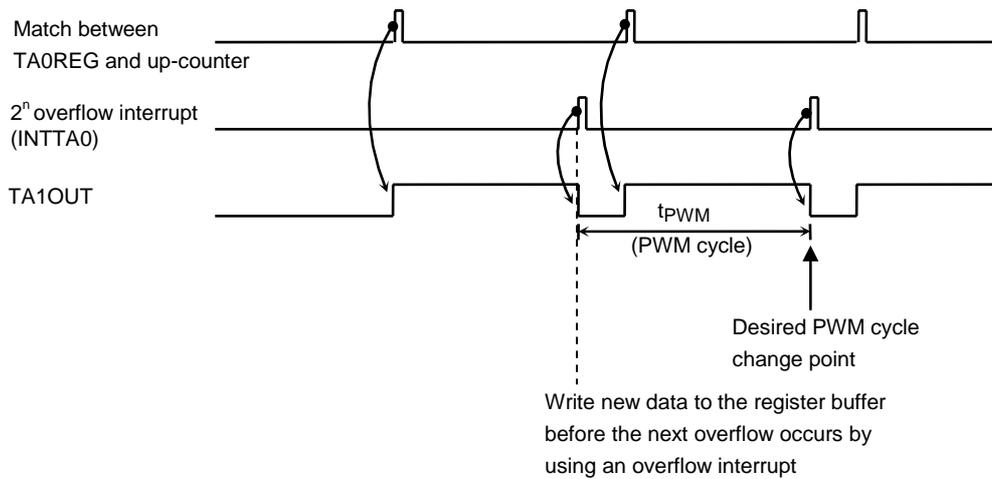
Example when using PWM mode

If new data is written to the register buffer immediately before an overflow occurs by a match between the timer register value and the up-counter value, the timer flip-flop may output an unexpected value.

For this reason, make sure that in PWM mode new data is written to the register buffer by six cycles ($f_{sys} \times 6$) before the next overflow occurs by using an overflow interrupt.

Write new data to the register buffer by six cycles before the next overflow occurs, using the interrupt routine to be activated by an overflow interrupt.
