## **Important Notices**

## **Restriction on Use of 8-bit Timers**

## Datasheet Modifications: PWM Cycle of 8-bit Timers

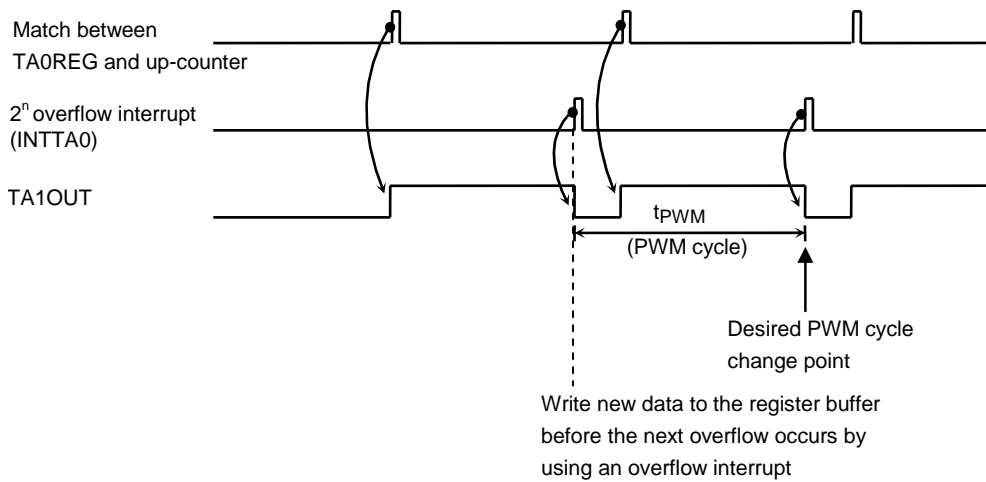
Example when using PWM mode

If the timer register of an 8-bit timer is updated under the following conditions, the timer flip-flop may output an unexpected value.

- When the 8-bit timer is used in PWM or PPG mode
- When the double buffer is enabled
- When the data in the register buffer is updated immediately before an overflow occurs in the up-counter

When the double buffer is enabled for an 8-bit timer in PWM or PPG mode, caution is required as explained below.

If new data is written to the register buffer immediately before an overflow occurs by a match between the timer register value and the up-counter value, the timer flip-flop may output an unexpected value.

(1) Disable the double buffer.

(2) Observe the following timing requirement when writing new data to the register buffer:

a) In the case of using PWM mode

Write new data to the register buffer by six cycles before the next overflow occurs, using the interrupt routine to be activated by an overflow interrupt.

For this reason, make sure that in PWM mode new data is written to the register buffer by six cycles ( $f_{sys} \times 6$ ) before the next overflow occurs by using an overflow interrupt.
