Important Notices

Restriction on Use of 8-bit Timers

Datasheet Modifications: Interrupt controller

Datasheet Modifications: PWM Cycle of 8-bit Timers

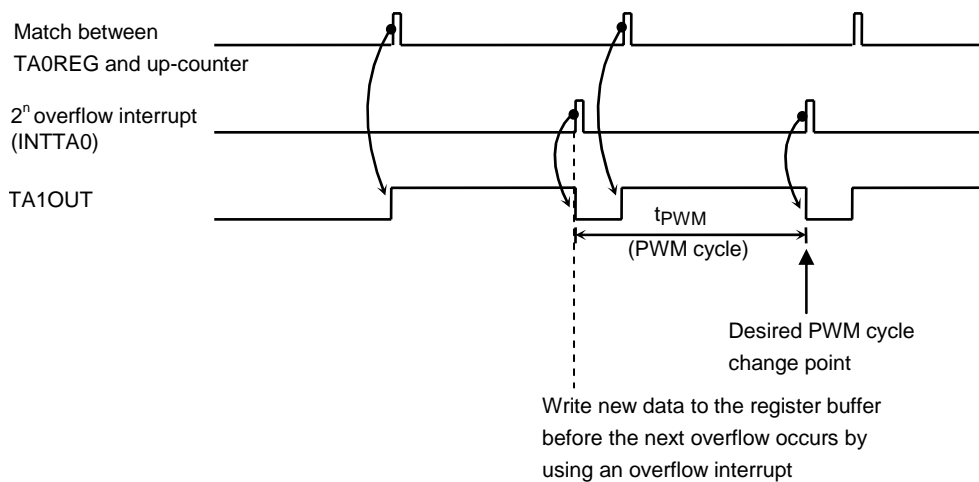
Example when using PWM mode

If the timer register of an 8-bit timer is updated under the following conditions, the timer flip-flop may output an unexpected value.

- When the 8-bit timer is used in PWM or PPG mode
- When the double buffer is enabled
- When the data in the register buffer is updated immediately before an overflow occurs in the up-counter

If new data is written to the register buffer immediately before an overflow occurs by a match between the timer register value and the up-counter value, the timer flip-flop may output an unexpected value.

For this reason, make sure that in PWM mode new data is written to the register buffer by six cycles ($f_{\text{sys}} \times 6$) before the next overflow occurs by using an overflow interrupt.

- (1) Disable the double buffer.

- (2) Observe the following timing requirement when writing new data to the register buffer:

Write new data to the register buffer by six cycles before the next overflow occurs, using the interrupt routine to be activated by an overflow interrupt.

Write new data to the register buffer by six cycles before the next cycle compare match occurs, using the interrupt routine to be activated by a cycle compare match interrupt (*).
